# Evaluation of Experimental Laser-Induced-Damage Assessment Techniques For Solid-State Nonlinear Optical Elements

## ABSTRACT

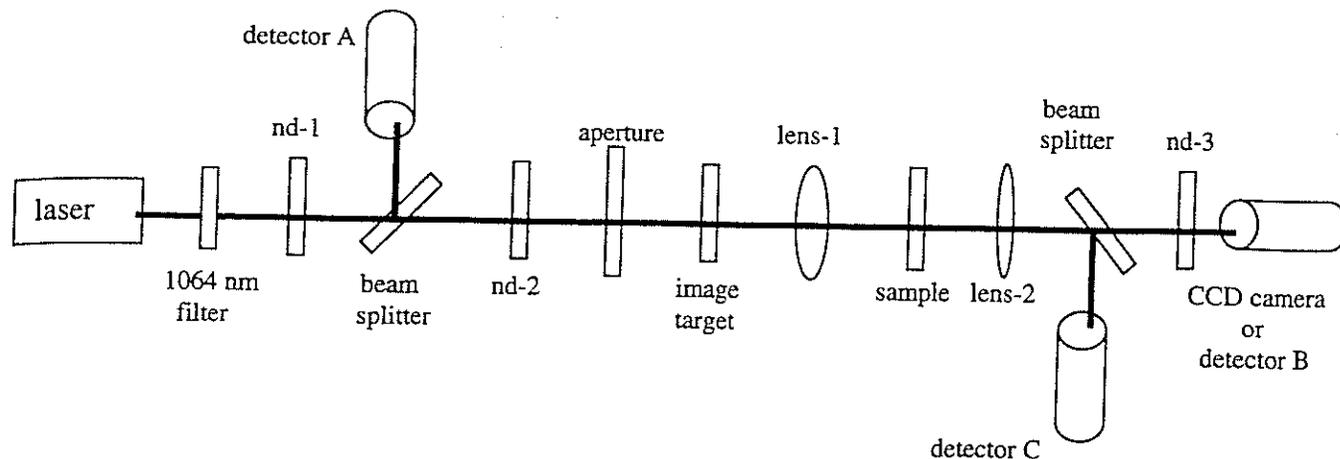
An  $f/5$  focusing geometry was used to evaluate laser-induced damage. A schematic is shown in Fig.1. A frequency doubled Nd:YAG laser was used to create 10 ns pulses at 10 Hz repetition rate. The diameter of the beam at the laser output is approximately 1 cm. Residual 1064 nm radiation is removed from the beam by a filter located at the laser output. Filters at ND-1 are used to control the energy entering the measurement system. A beam splitter directs approximately 10% of the incident energy toward detector-A, which is used to monitor and compensate for variations in laser output. Filters at ND-2 are used to balance energy within the system. The beam passes through a 6.67 mm diameter aperture and is then incident on a negative 1951 USAF resolution target measuring 2x2 inches. A 33 mm focal length lens then focuses the laser energy into the sample under study. A 70 mm lens collects light emerging from the sample and focuses the resolution target image onto a CCD array. A beam splitter directs a portion of the transmitted energy to detector C, which is used to monitor changes in transmission. Neutral density filters at ND-3 are used to balance the dynamic range of the system. Data were acquired via PC-based, commercial data acquisition and analysis software. A LeCroy LC574A 1 GHz digital oscilloscope was used for some portions of the study.

Figure 1. Experimental Setup

Throughout this study, a single solid polyurethane sample was used. The sample is approximately 2 mm thick and measures 2 X 2 inches. The sample was located at the focus of lens 1 shown in Fig. 1. The measured focused spot diameter was 40 $\mu$ m. The sample was tested for evidence of nonlinear absorption, but no such effect was found. Damage induced changes in transmission were monitored for each laser pulse by taking the ratio of voltage readings at detectors C and A:

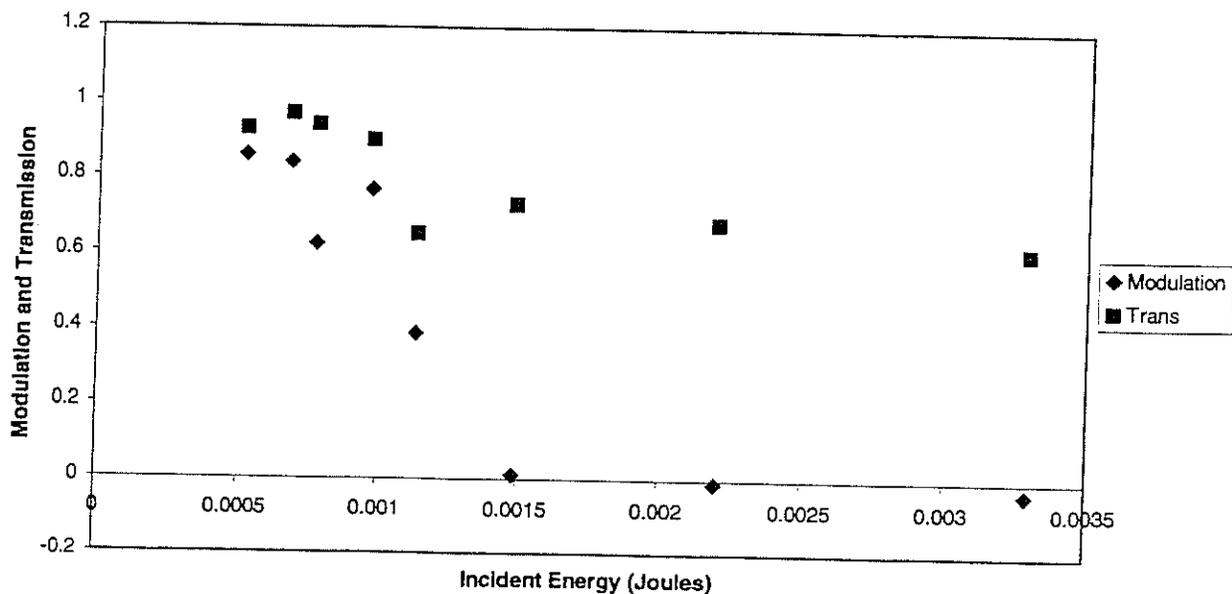
Using the CCD camera, an image was acquired for all three pulses within a set. Visual comparisons were made of all three images and the modulation was calculated for each using Eq. 5. Transmission values were calculated using Eq. 6. The results are shown in Fig. 2.

Figure 2. Modulation and transmission versus input energy for single-shot data.

The transmission curve shown in Fig. 2 falls off more slowly than the modulation. This may be more an artifact of the particular experimental setup used in the study than an indication that the modulation method is more sensitive. Transmission sensitivity can be increased by placing an aperture before the throughput detector to reduce scattered light from the damage site into the detector. The modulation curve in Fig. 2 shows some variation in the point at which it begins to fall off from the linear region. Close study of the data indicates that the variations are real and are attributed to local variations in sample characteristics such as surface condition and inclusions. Variations in modulation values were attributed, in some cases, to shot-to-shot variations in the laser beam spatial profile. Visual inspection via line scans was found to be the most reliable method of ascertaining the onset of laser induced damage. Image blur in the spaces of the resolution chart image becomes immediately apparent to the observer.

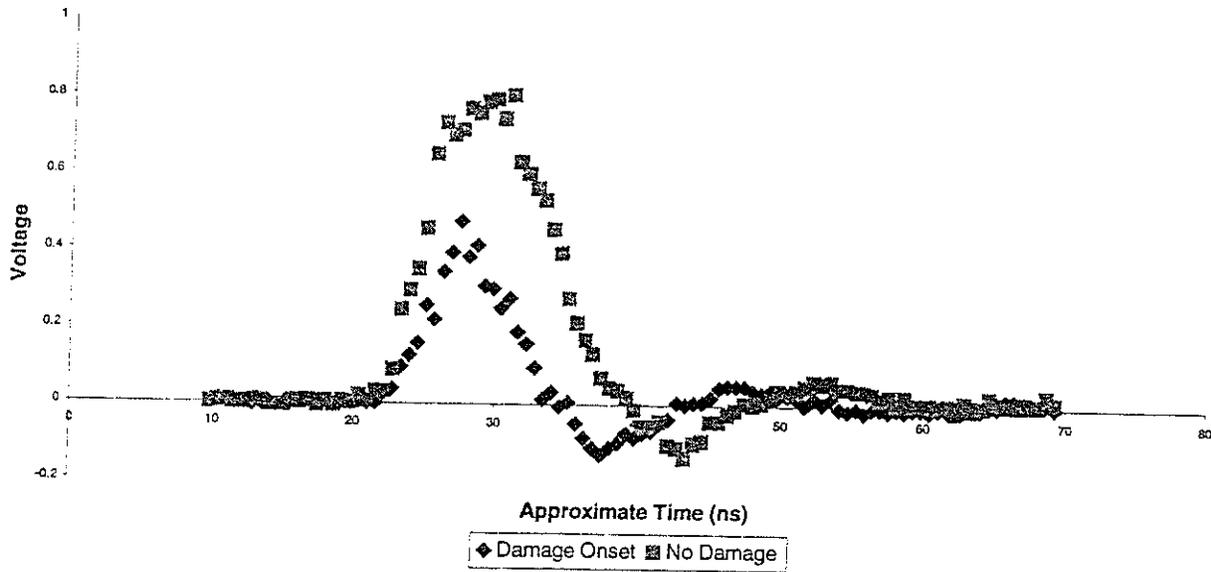
Using a silicon photodiode and a 1 GHz digital oscilloscope a trace was generated of the temporal profile of the laser used in the analysis. This trace was compared to that of a single shot pulse creating damage to the sample. The traces are shown in Fig. 3. Deviation is evident between the two traces early on in the pulse indicating the early onset of damage for this energy level and experimental configuration.

Figure 3. Oscilloscope traces showing laser spatial profile before damage and during damage onset.

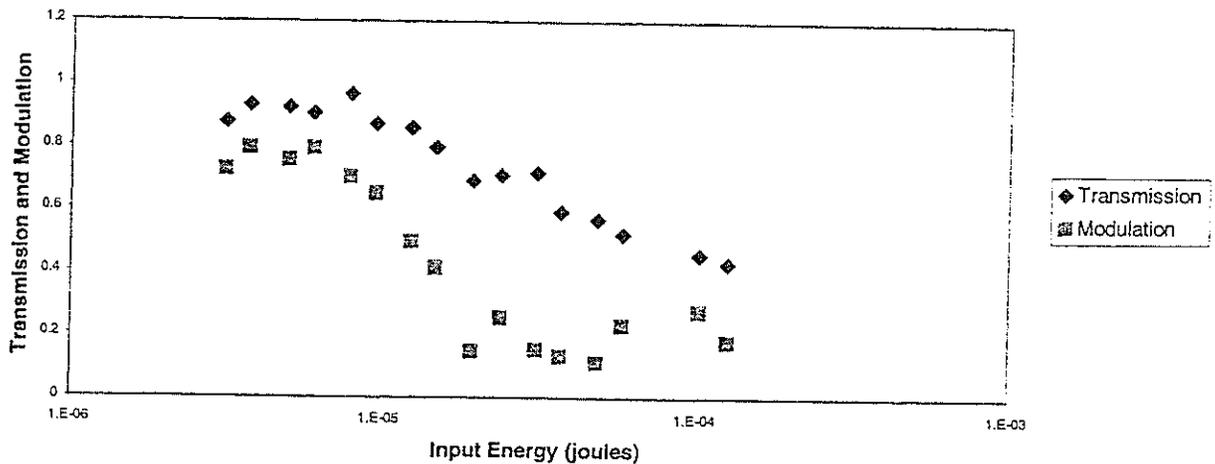
Case 2: To reduce noise and thus improve reliability in the assessment of single shot transmission and modulation values, another single-shot run was performed. In this study a number of single shot pulses were recorded for a given input energy, each at a different sample location. Transmission and modulation values were calculated for each pulse. Data relating to a specific energy level were then averaged. The results are shown in Fig.4.

Figure 4. Transmission and modulation versus input energy for averaged single-shot data.

As with the results shown in Fig. 2 for Case 1, the modulation deviates from the linear region at a lower energy than the transmission curve, indicating a higher sensitivity as a damage assessment tool. Noise in the linear region makes it difficult to determine the point at which damage occurs for both the modulation and the transmission curves. The noise is due in part to differences in the damage threshold from one location to the next. Without actually seeing the potential damage site, it is difficult to know whether small changes are due to damage or noise. However, in the modulation case, visual inspection of the image allows one to detect the onset of damage-induced image blur regardless of the noise source. One might conclude from the transmission curve that damage had occurred at point 9. By visual inspection of the images we conclude that damage actually occurred at point 5.

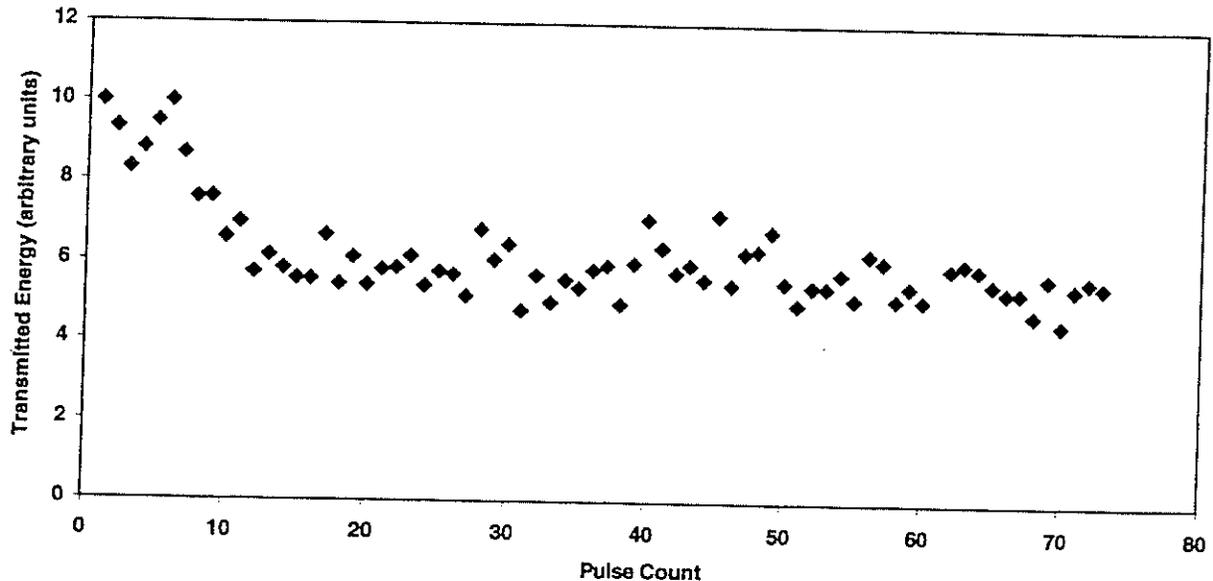
Figure 5. Transmitted energy versus pulse count for multiple shot data.

Figure 5 shows transmitted energy as a function of pulse count for a damaged sample. The decrease in throughput energy is attributed to increased scattering at the damage site. The change in transmission is system-specific in that it can be altered by varying the location of the CCD camera, or the size and location of an aperture located after the sample and before the throughput detector.

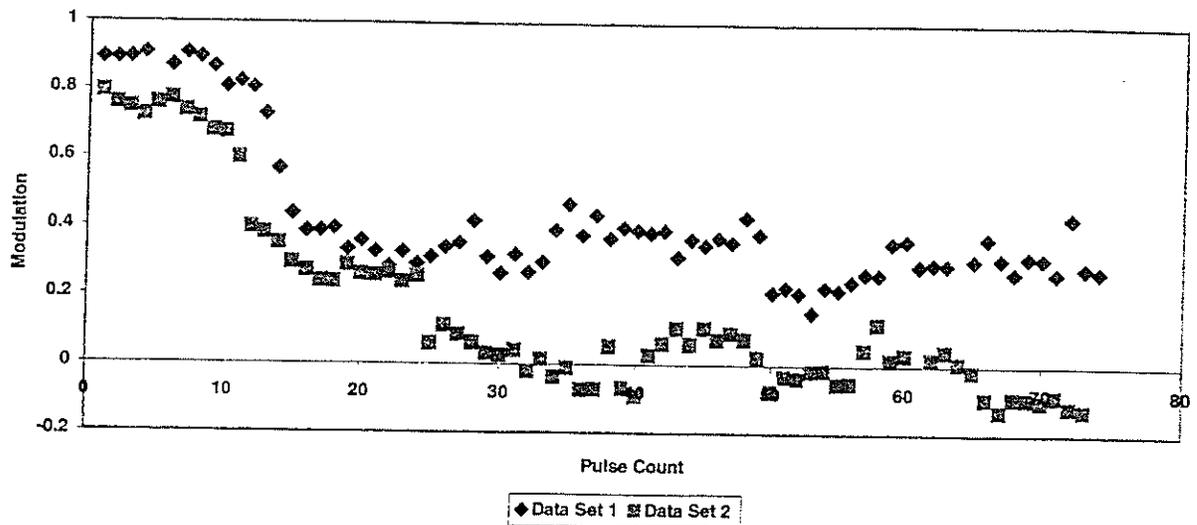
The general trend shown in Fig. 5 is repeated in terms of image degradation in Fig. 6. Here modulation is calculated using Eq. 5 for two different runs where data were acquired as described above. Again, the linear region is evident for about the first 10 pulses after which a clear change in modulation can be seen. Discontinuities in the data are due to the images being acquired in groups of eight. This variation is of interest because it shows the way in which the damage threshold of a material can change from one location to another due to variations in surface characteristics, inclusions and subtle changes in the intrinsic polymer mechanical properties.

Figure 6. Modulation versus pulse count for two sets of multiple shot data.

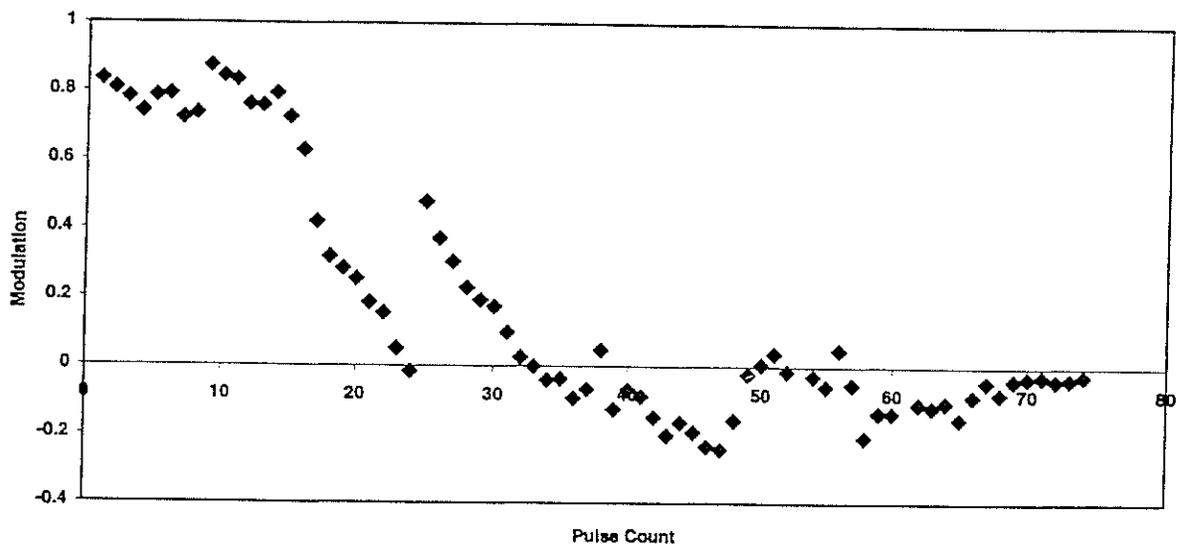
This variation in damage threshold was particularly evident in one multiple shot run. In the data set shown in Fig. 7, there is variation of about ten pulses between the 3<sup>rd</sup> and 4<sup>th</sup> groups-of-eight where the modulation goes to zero. The sample location where the 4<sup>th</sup> set of eight images was acquired appears to be particularly robust.

Figure 7. Modulation versus pulse count for multiple-shot data. Data depicts variation in localized damage threshold for a single sample.

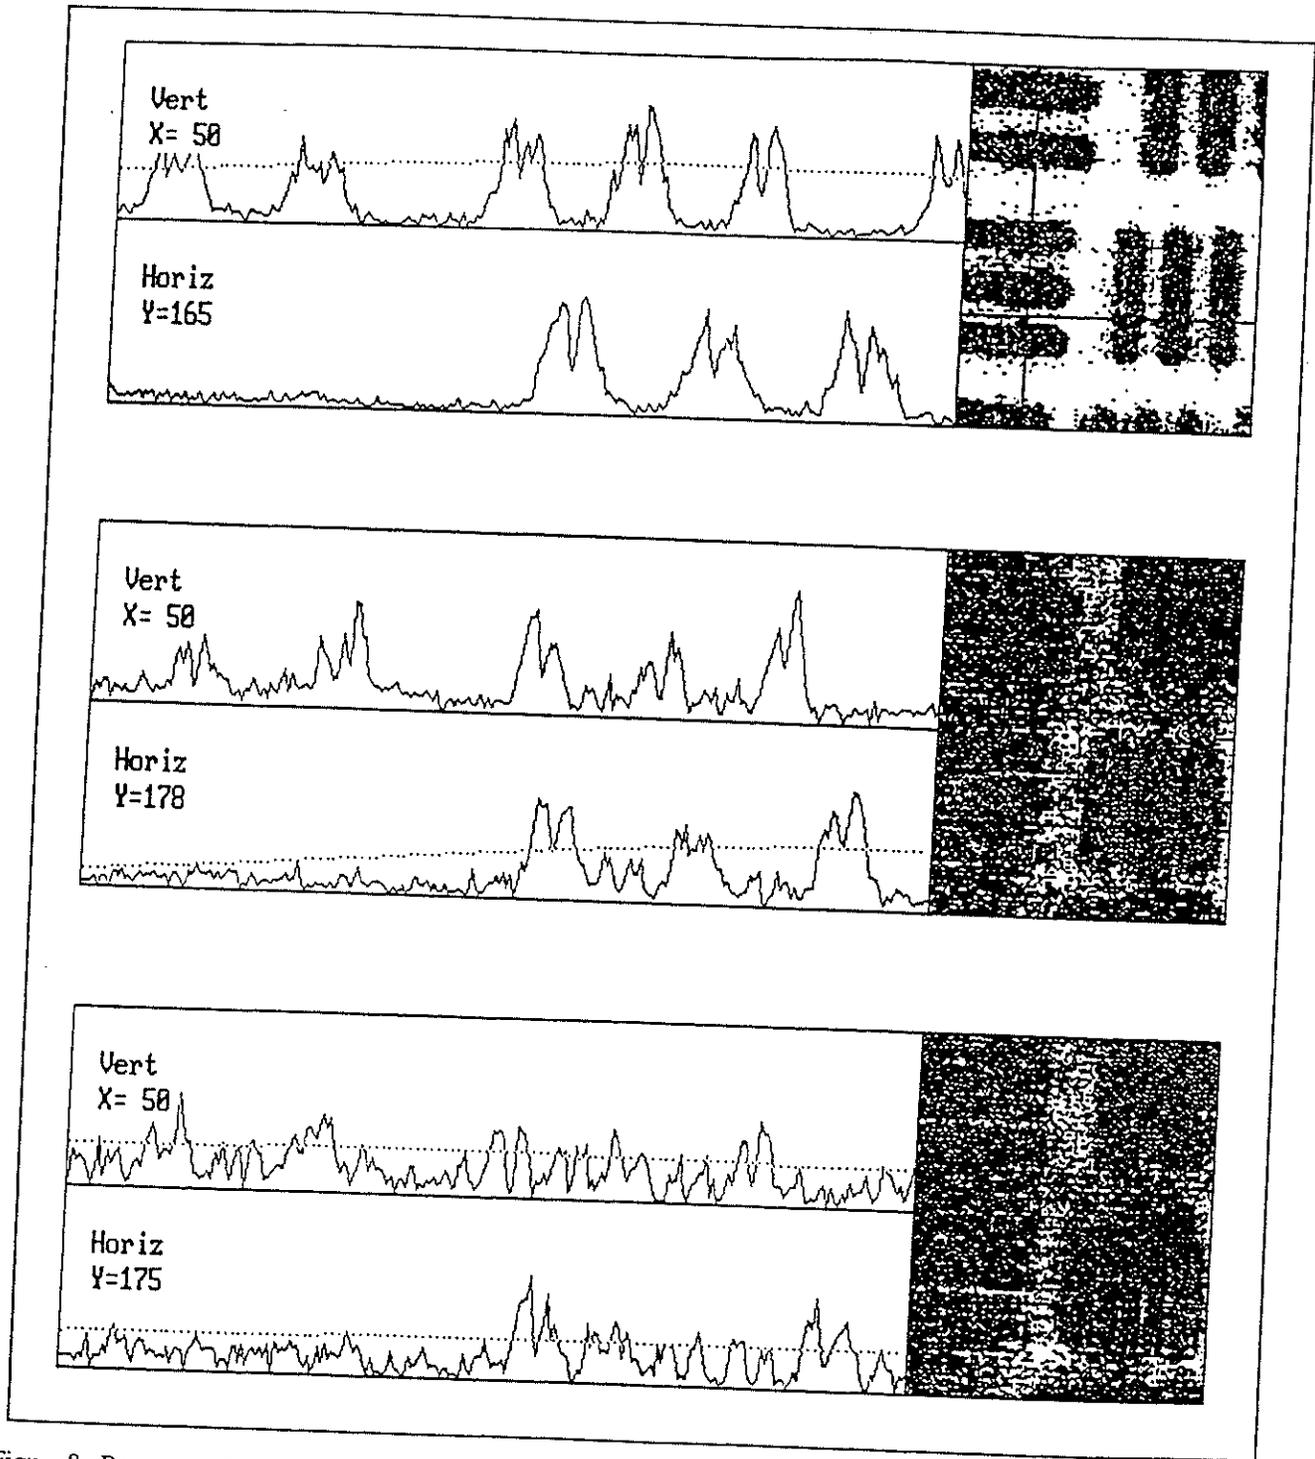
Figure 8 shows three images depicting various stages of damage during a multiple shot run similar to that shown in Fig. 7. In the first image, the line scans show well defined contrast between the lines and spaces of the resolution pattern. The spaces of the second image show increased image blur associated with the damage site. In the third image the pattern is barely discernable. It is by observing the point at which the spaces begin to show intensity growth that one is able to determine the onset of laser-induced damage.

Figure 8. Representative images and corresponding line scans for three data points used to calculate image modulation

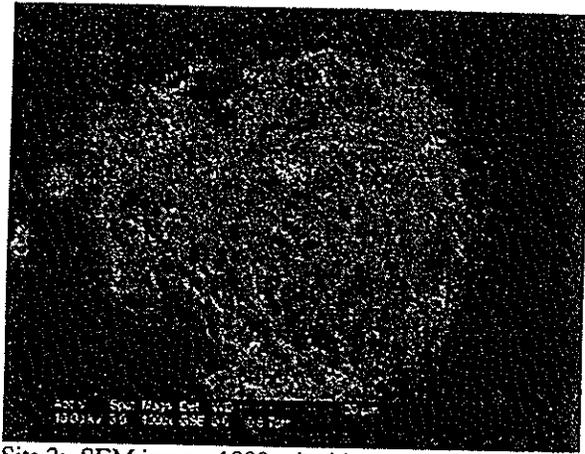
Figure 9 shows micrographs of representative damage sites. These do not correlate with the images shown in Figure 8. Sample transmission before damage was near 100%. Transmission through damage sites 2, 3 & 4 was 1.3%, 8.4% and 14%, respectively. SEM images were acquired using a Philips XL30 Electroscan. Light microscope images were obtained via a Zeiss Ultraphot.

Site 2: SEM image, 1000x, incident energy = 2.1 mJ

Figure 9. SEM micrographs of laser damage sites. Hole 2 is designated on the sample micrograph, followed by holes 3 and 4.

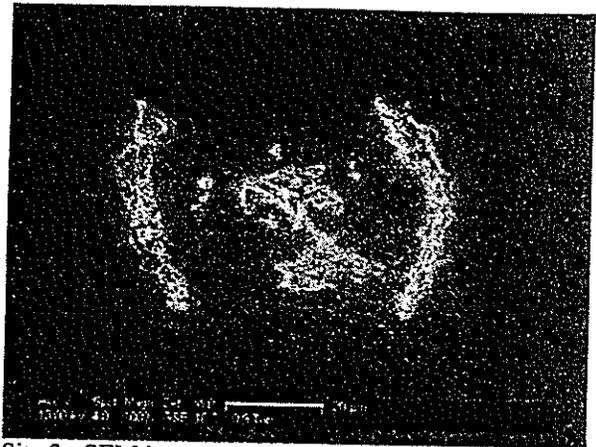
Site 3: SEM image, 1000x, incident energy = 1.2 mJ

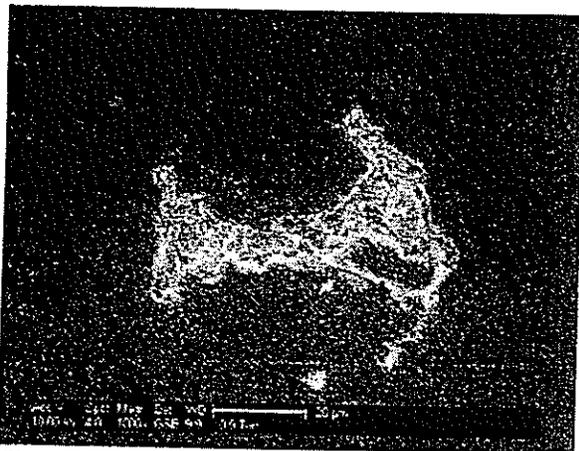
Site 4: SEM image, 1000x, incident energy = 0.7 mJ

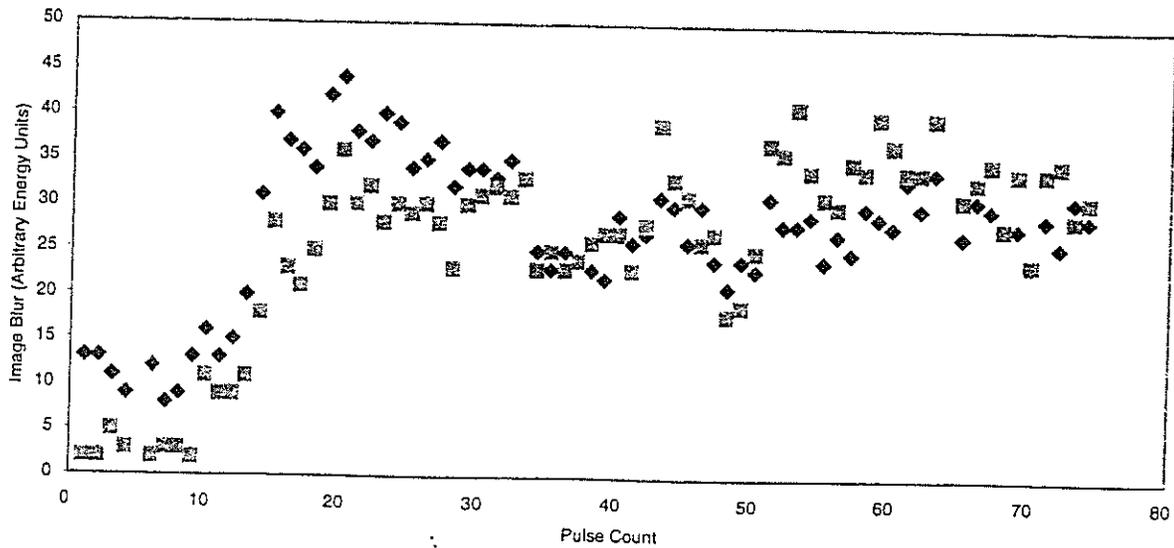
Fig. 10. Image blur intensity versus pulse count for multiple shot data.

In Fig. 10 the pixel intensity of the spaces in the line/space groups is plotted versus pulse count for two sets of data. A general trend is evident: as the sample becomes increasingly more damaged, the energy is displaced from the lines to the spaces of the image. In Fig. 11 a comparison is shown between modulation for a single-shot run and a multiple-shot run. Energy is cumulative for the multiple shot-data. That is, energy plotted for a given shot is actually a summation of energies from all previous shots to that of it's own. The multiple-shot data shows a higher damage threshold than the single-shot owing to the dissipation of energy as heat between pulses.

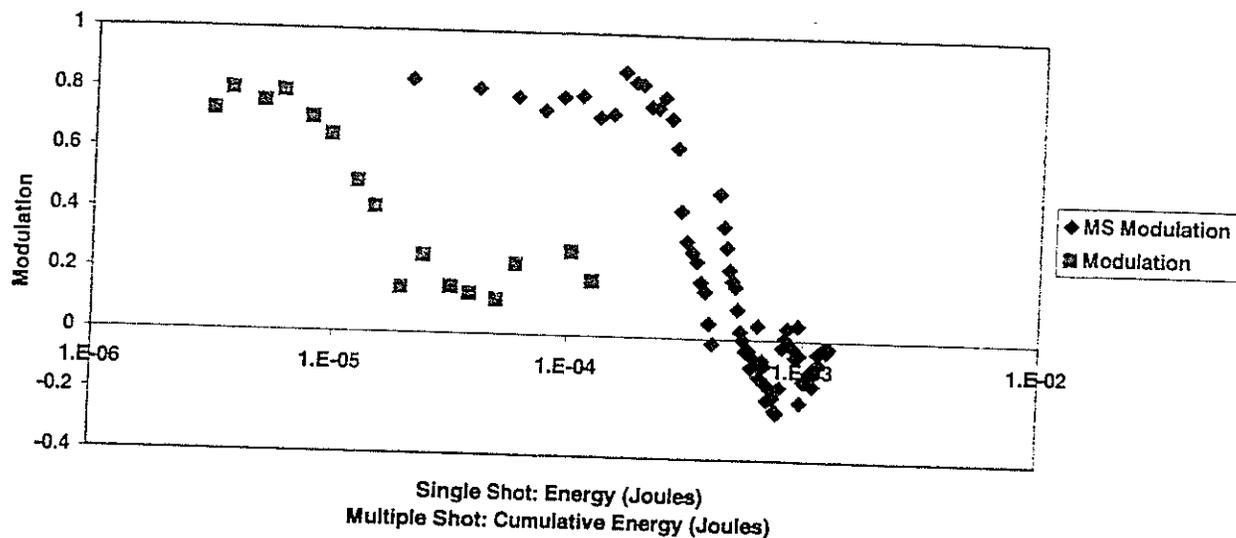
Fig. 11. Single-shot and multiple-shot modulation versus input energy.
